Toronto
Community
Housing

Engineering Report
Presented at the Swansea Mews Town Hall Meeting
June 14, 2022

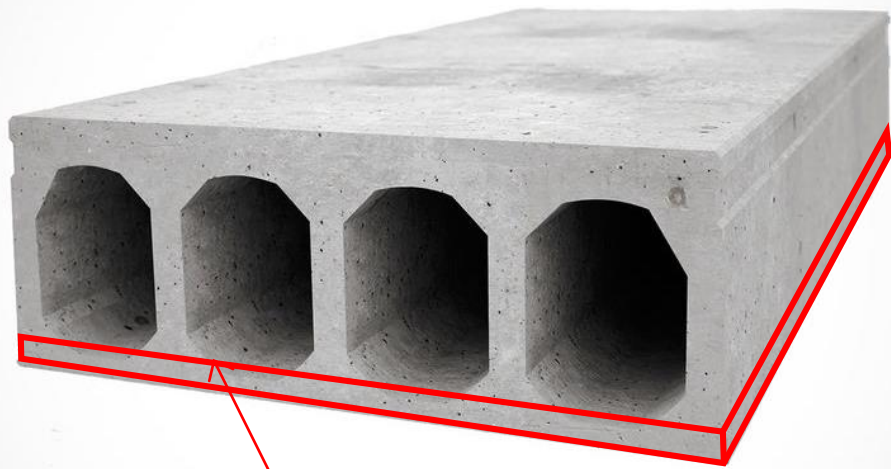
Construction joint found at Unit 19, not typical

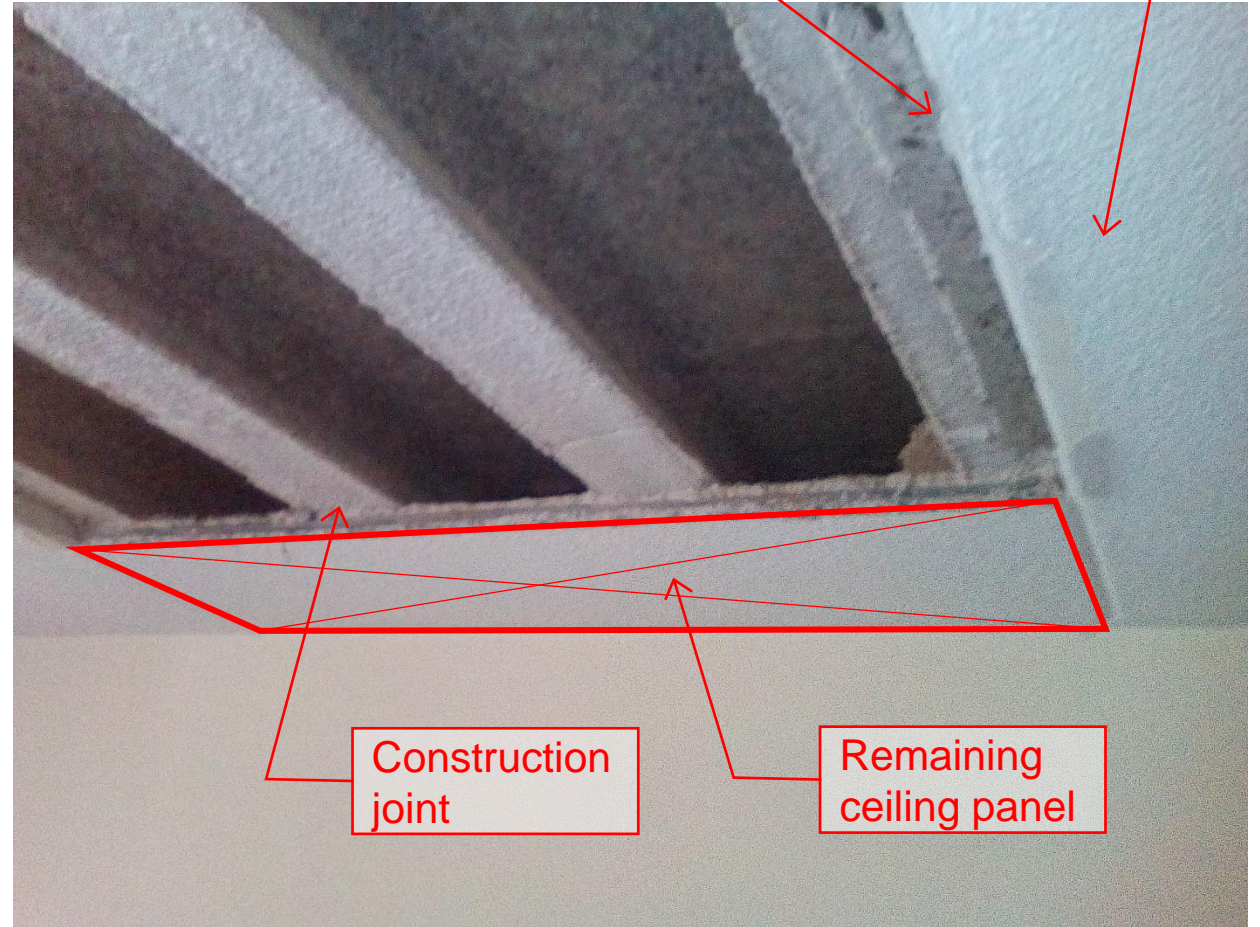
Precast panel in Unit 19

Joint between panels

Construction joint

Remaining ceiling panel

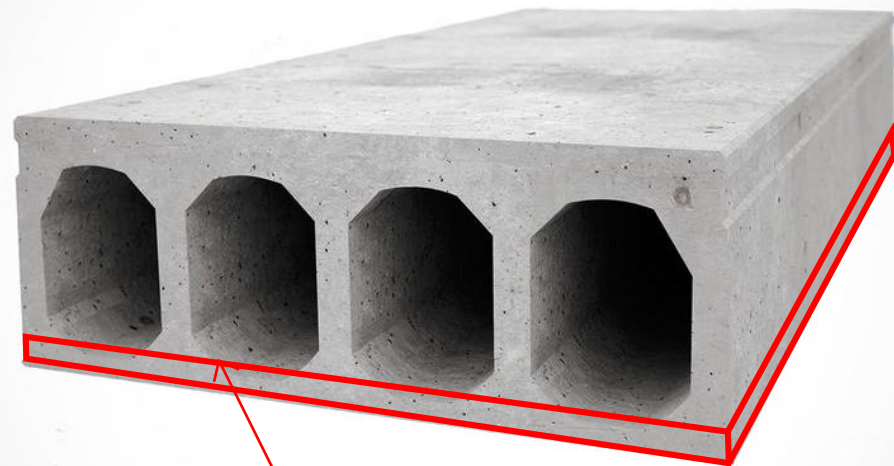
Construction joint found
at Unit 19, not typical

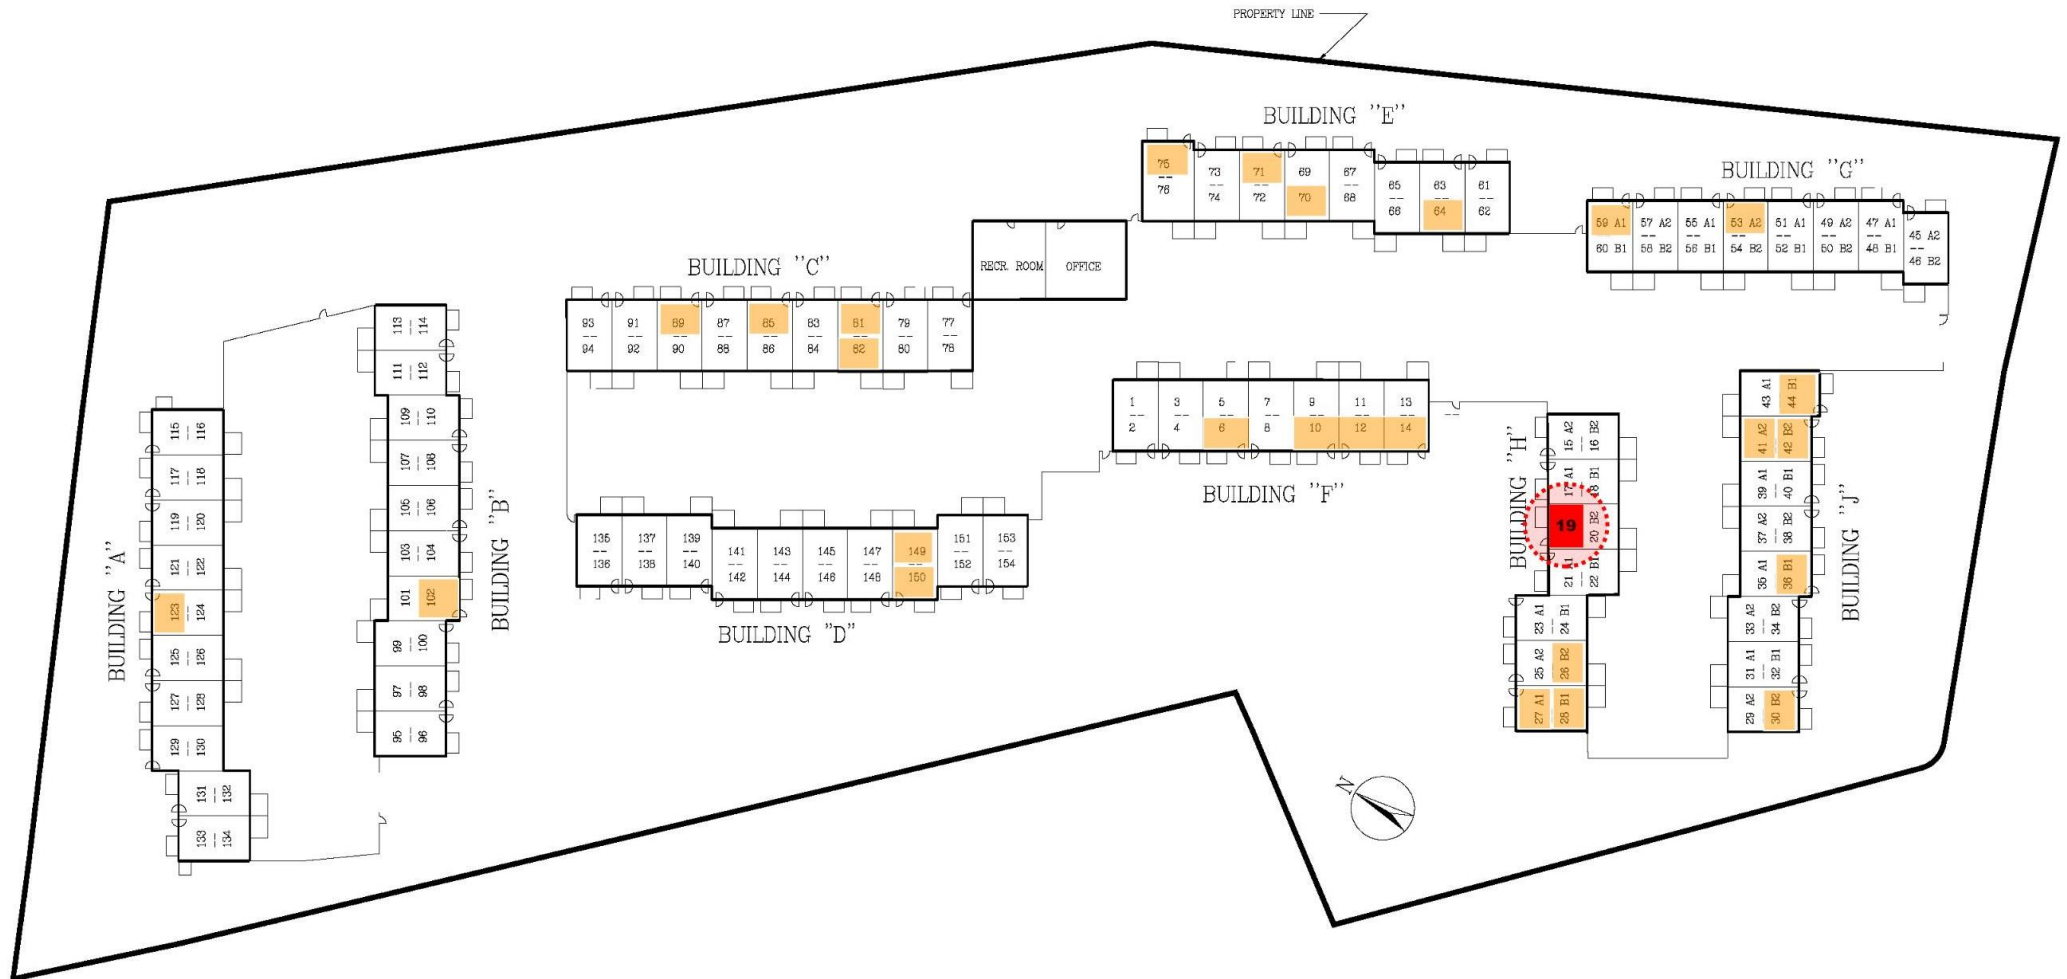
Electromagnetic Scanning Plan

27 (17.5%) of units scanned (or known)

5 / 378 (1.3%) of panels scanned (or known) exhibited detachment

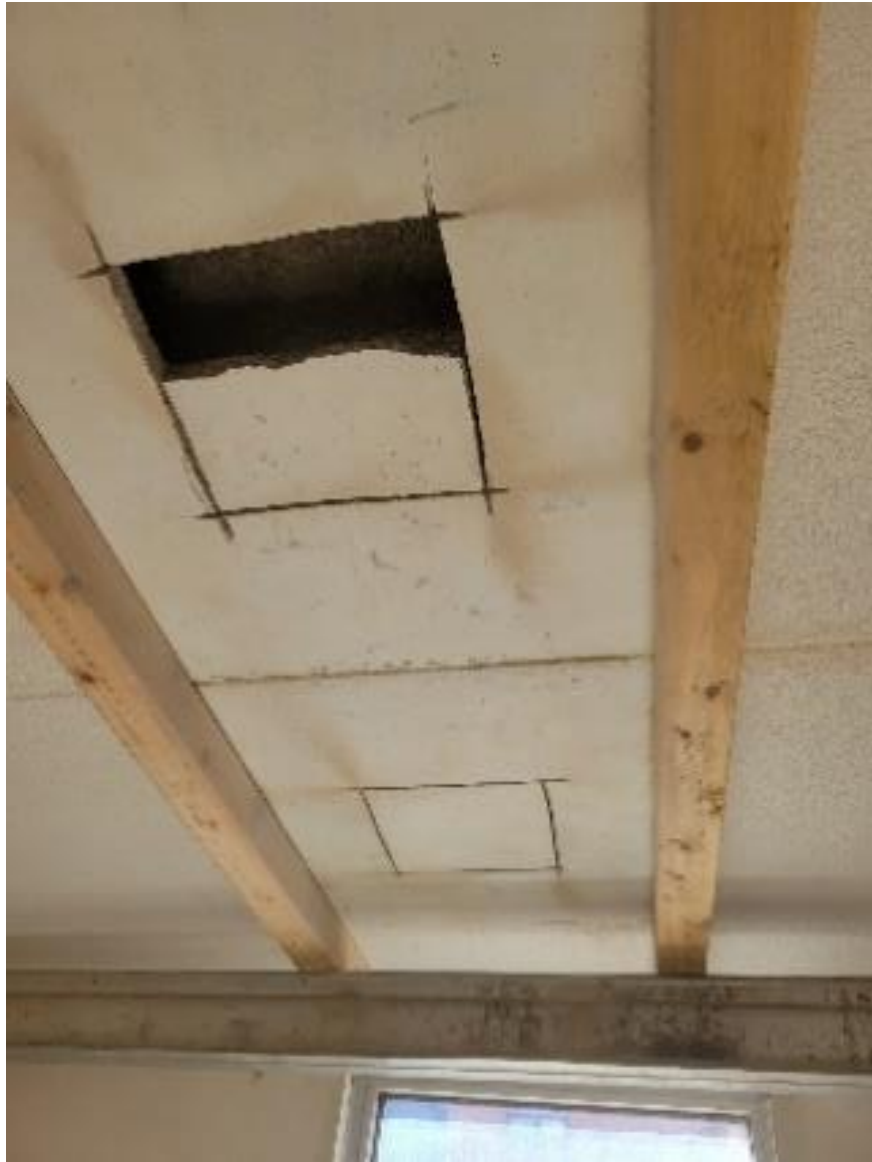
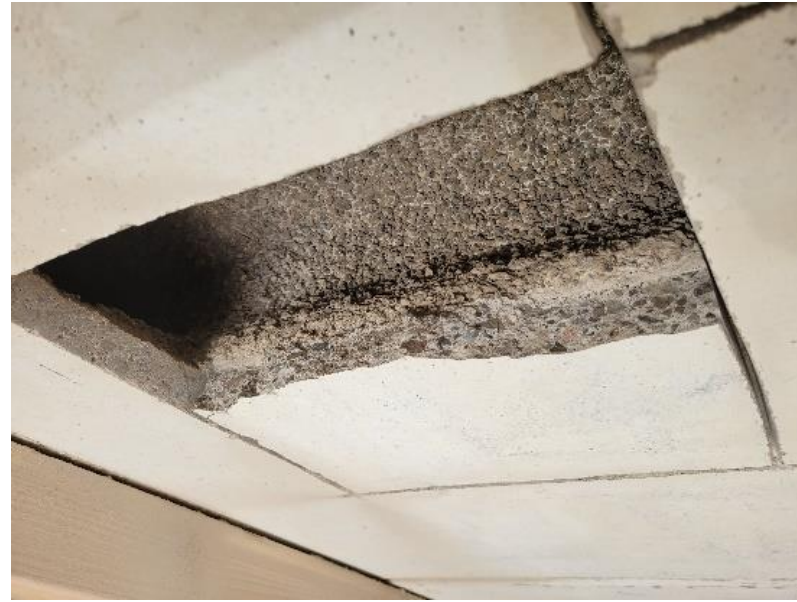
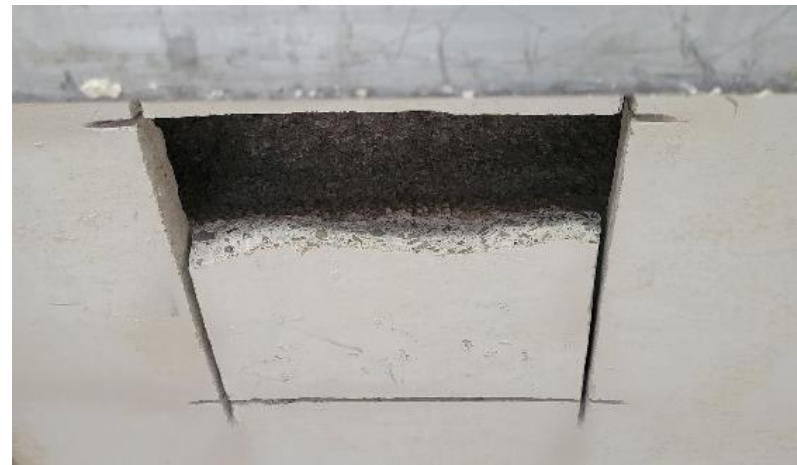
Examples of passing tests – underside of panel stays attached at “web”

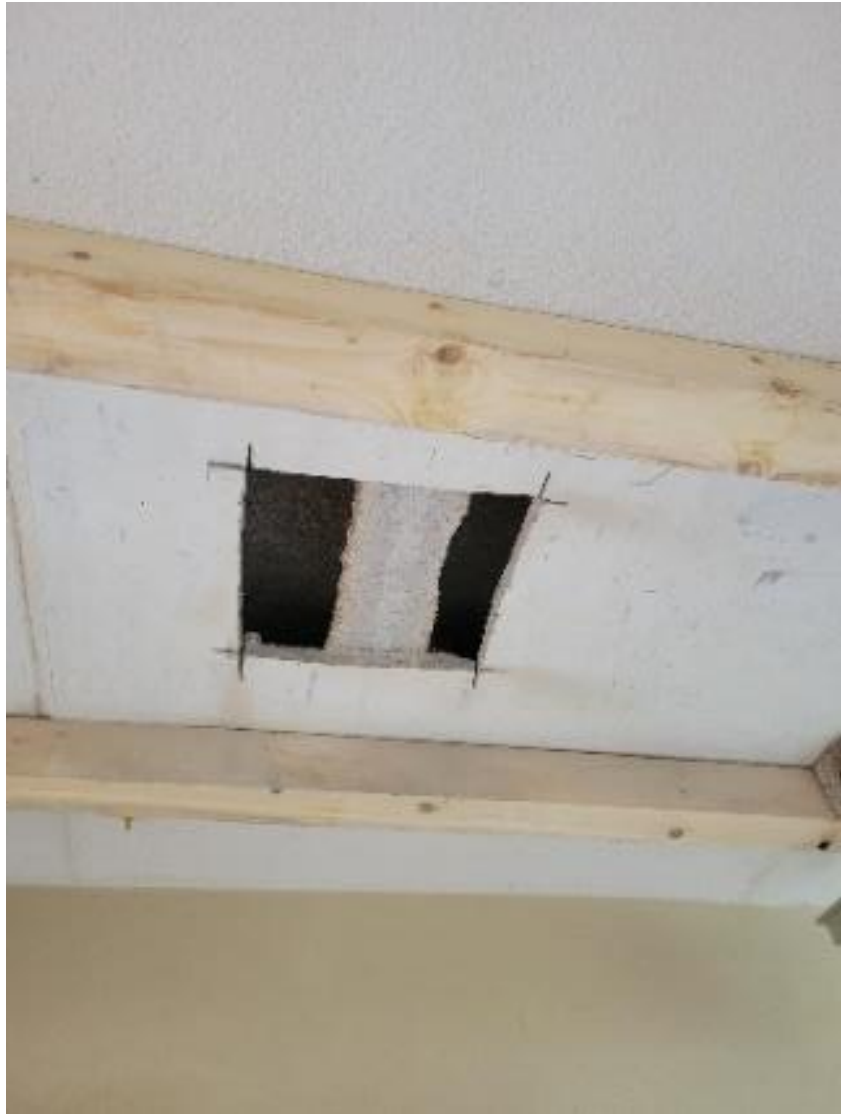
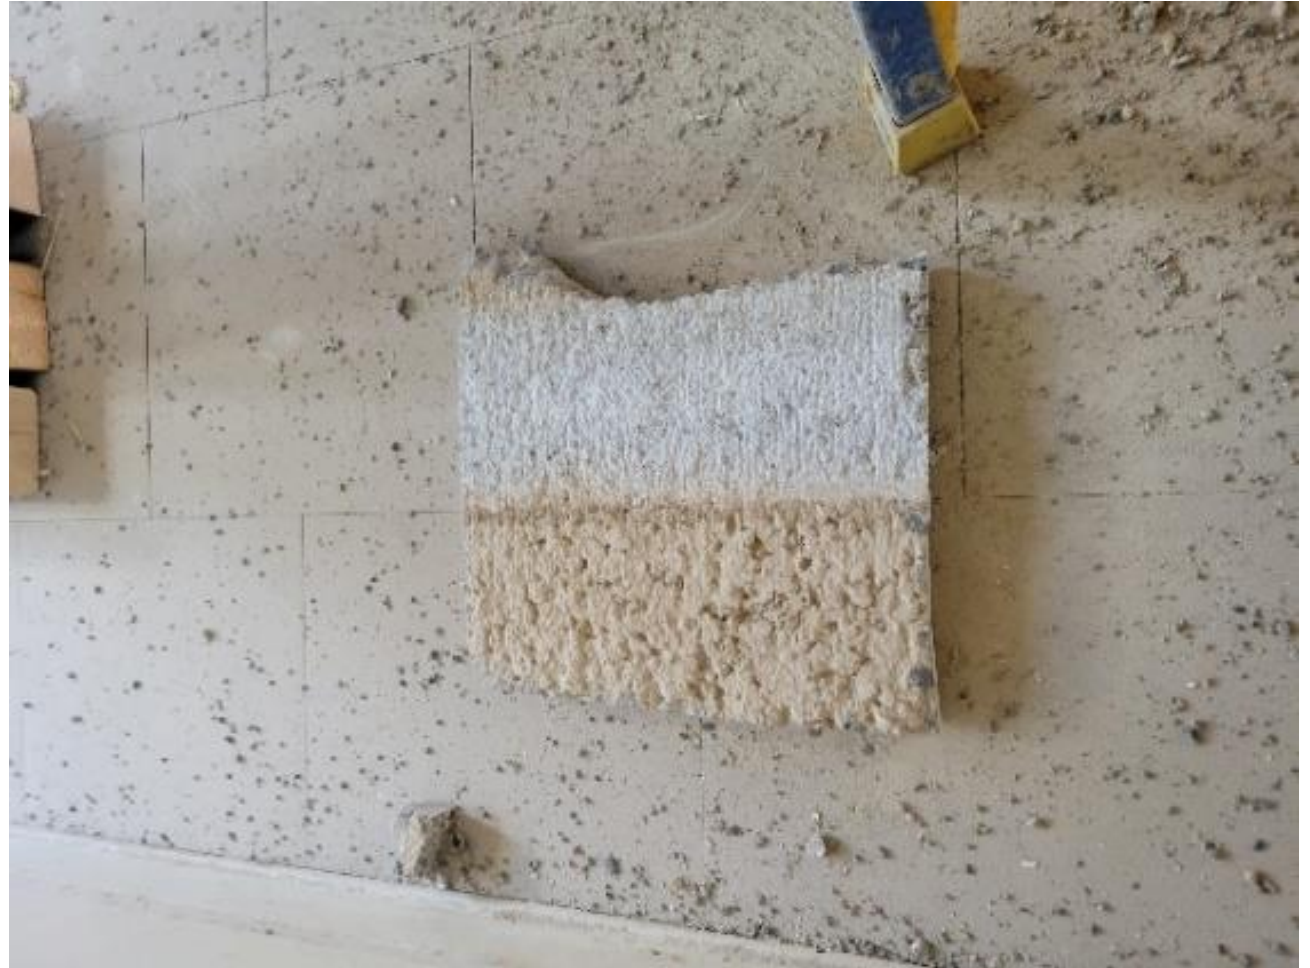
Example of failed test - panel failed clean separation occurred between underside of web and bottom of panel.

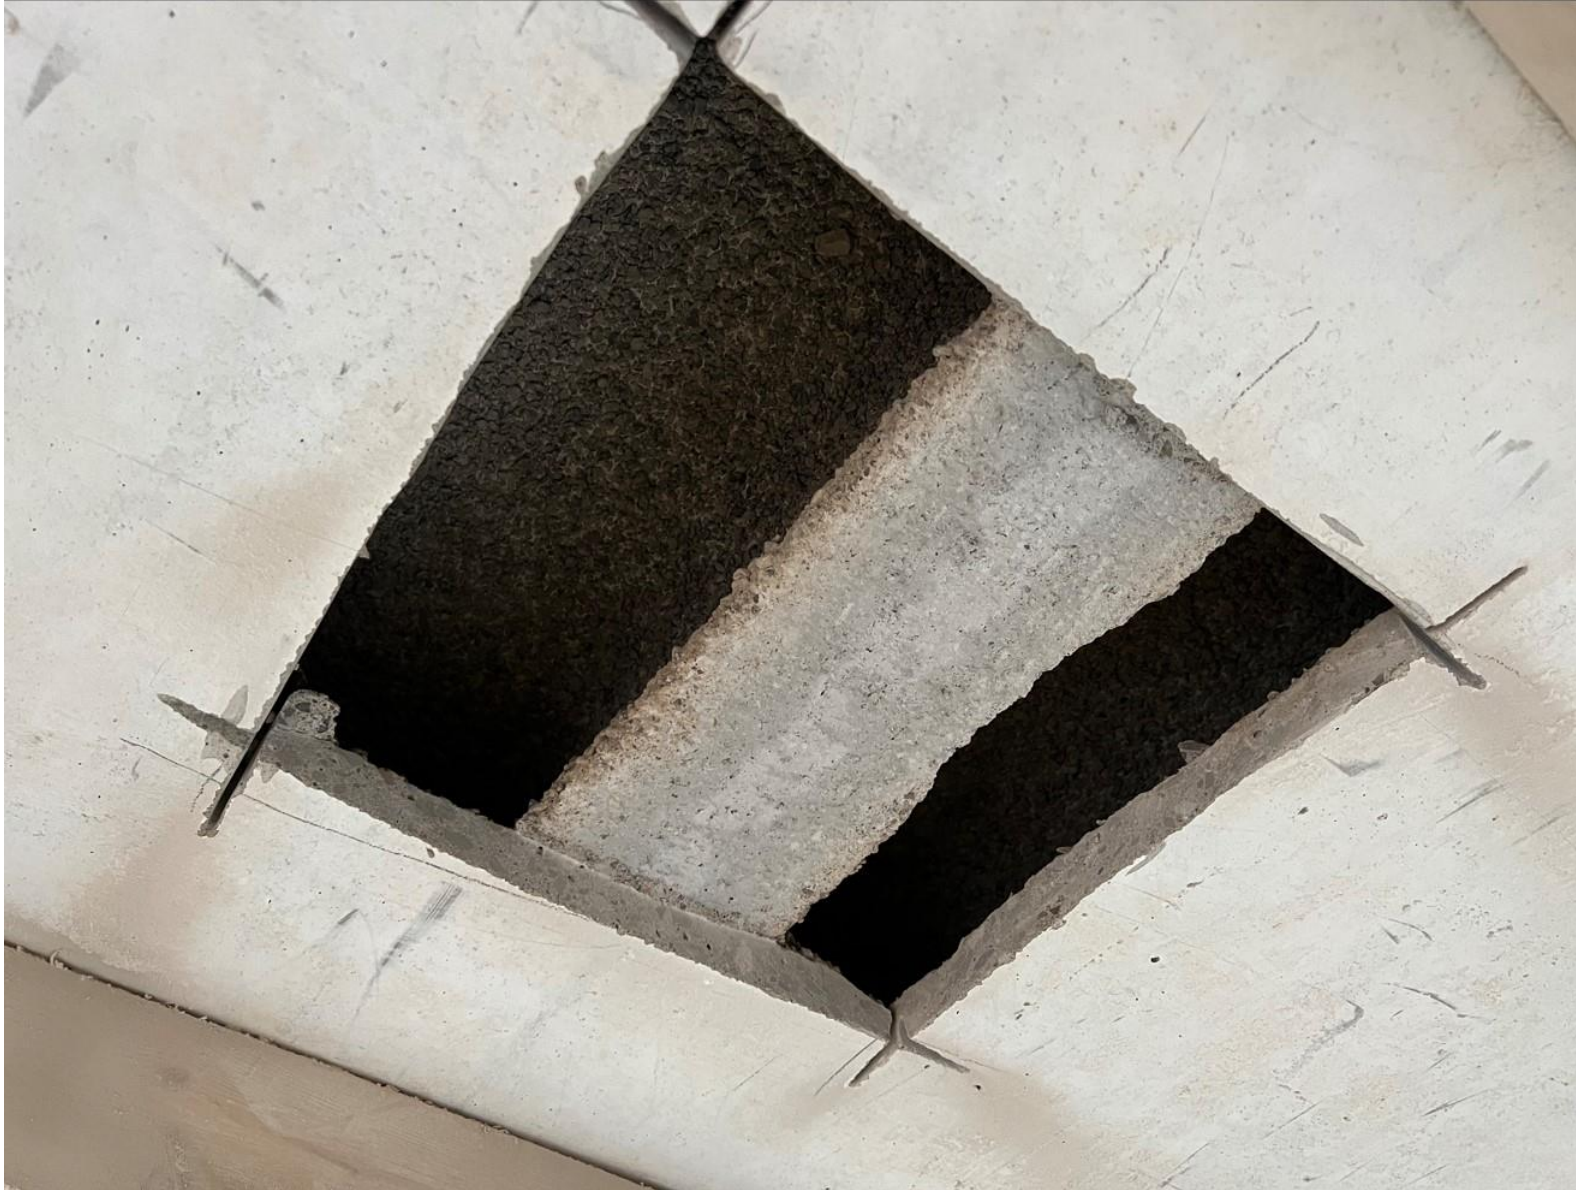
Destructive testing of the slab soffit (ceiling) – test shows a clear pour joint between the stems (main structure of the floor slab) and the soffit panel. Photo also illustrates that the concrete soffit is not reinforced (no bars or wire mesh visible at the cut lines) nor is there any physical connection to the stem.

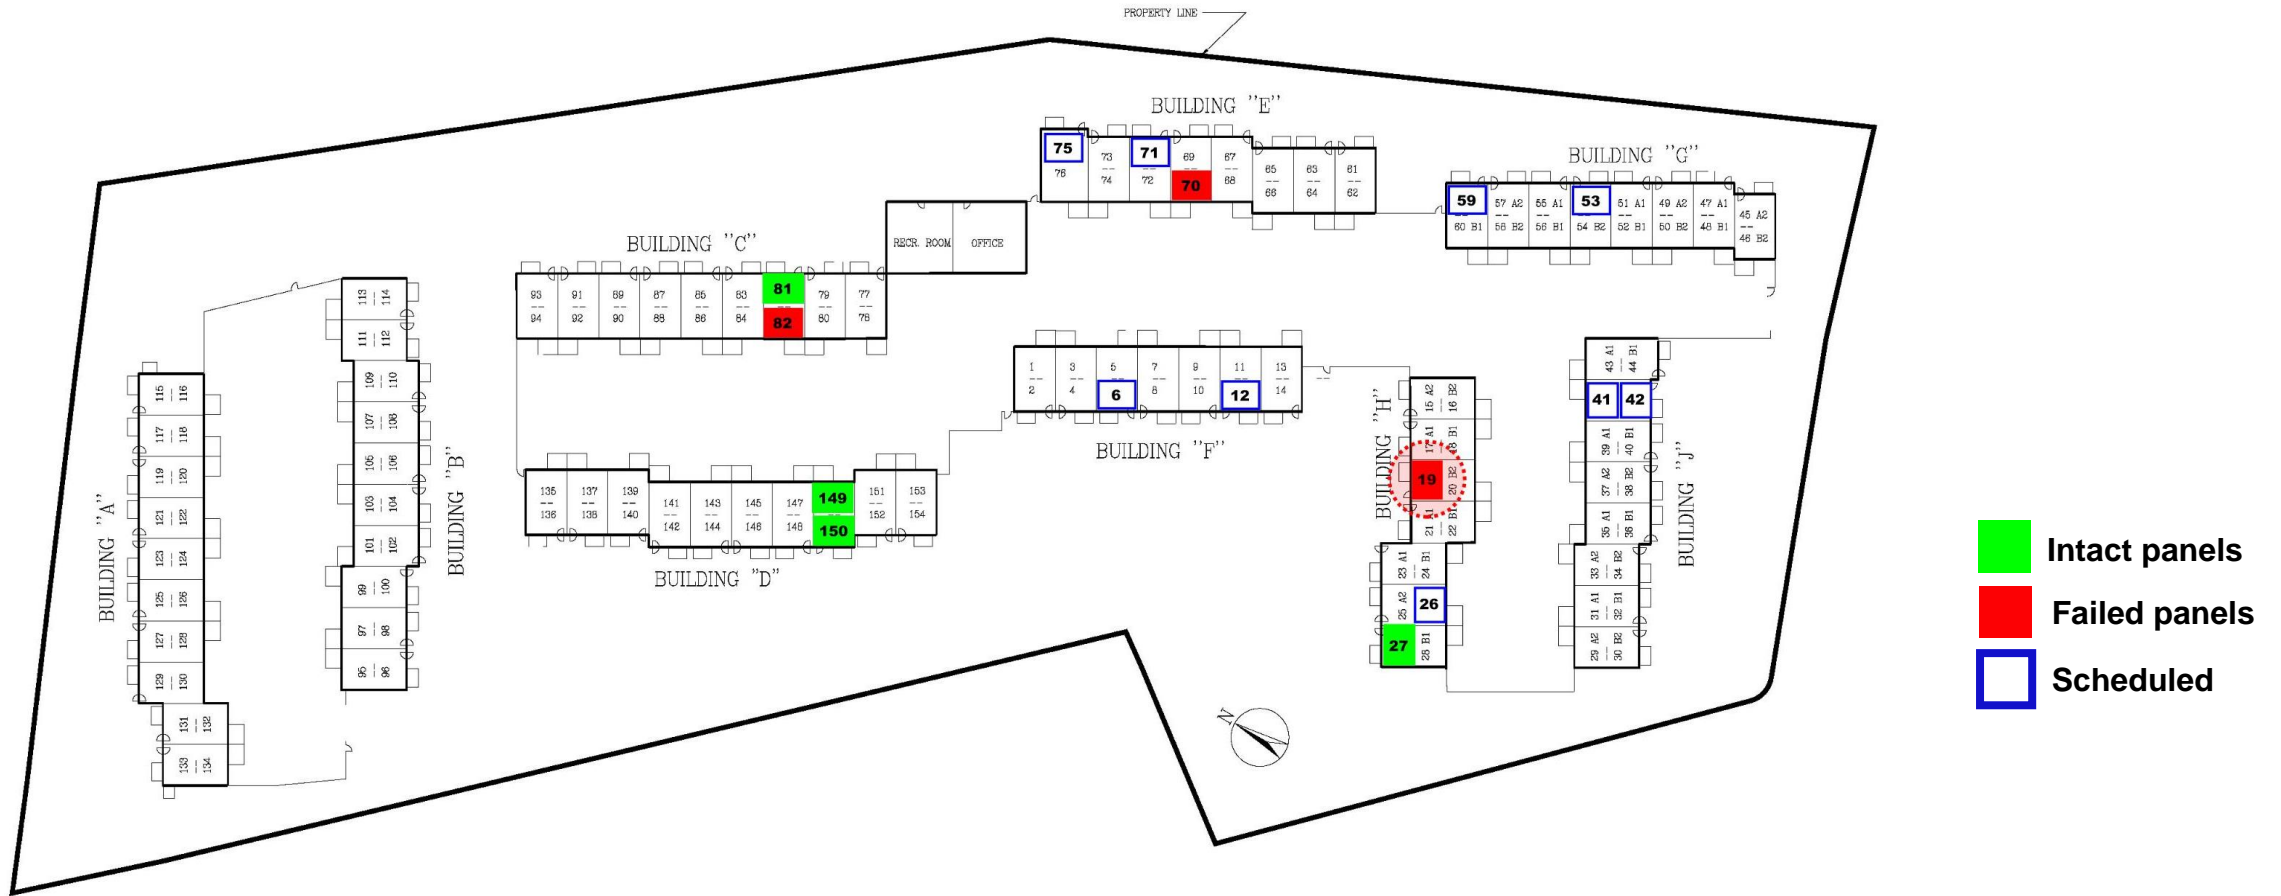
Destructive Testing Plan

3/14 (21%) of panels tested (or known) exhibited detachment

Based on these results, every panel in every unit must be tested in order to ensure safety of the tenants.
