**ONTARIO
SUPERIOR COURT OF JUSTICE**

**CITY OF TORONTO and
WILLIAM JOHNSTON, CHIEF BUILDING OFFICIAL
FOR CITY OF TORONTO**

APPLICATION RECORD

Engineering Report
Presented at the Swansea Mews Town Hall Meeting
June 14, 2022

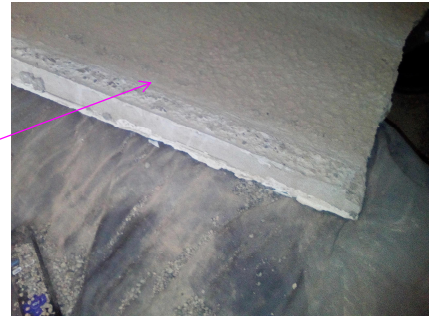
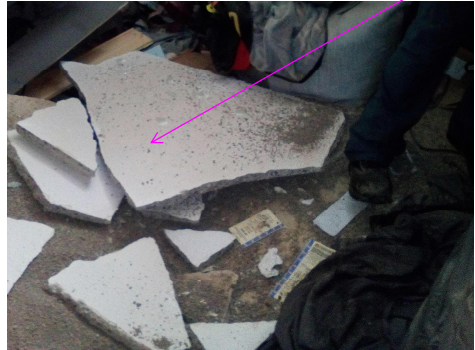
One precast panel approx. 1200mm

Fallen ceiling panel

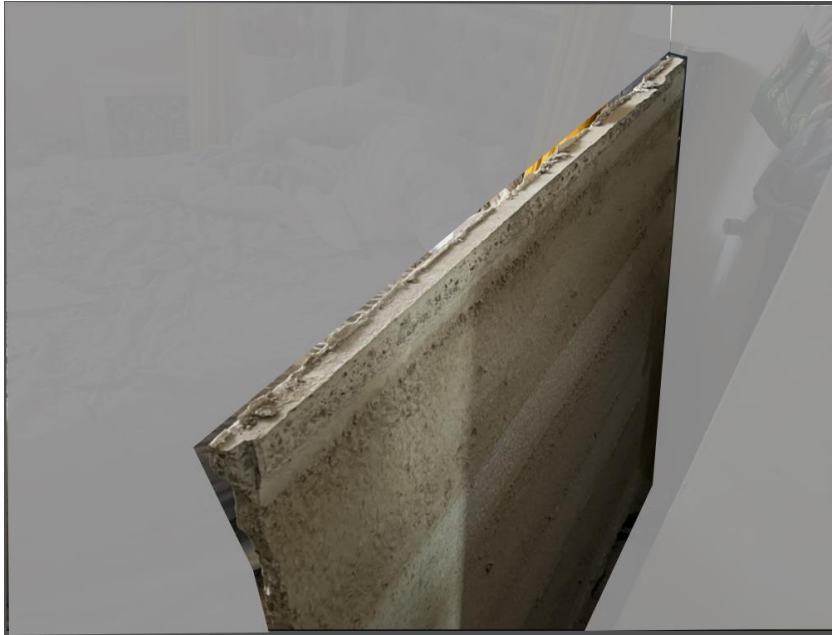
Figure 1: Section of Panel that fell

It is our understanding on the evening of May 26, 2022 or early in the morning of May 27, 2022 a sudden failure of the concrete soffit (i.e. the underside of the 3rd floor of the townhouse – Unit 20) occurred. A section of the underside of the hollow core precast panel approximately 10 feet long, by 4 feet wide and 1-1/2 inches thick fell (Refer to Figures 1 and 2 below).

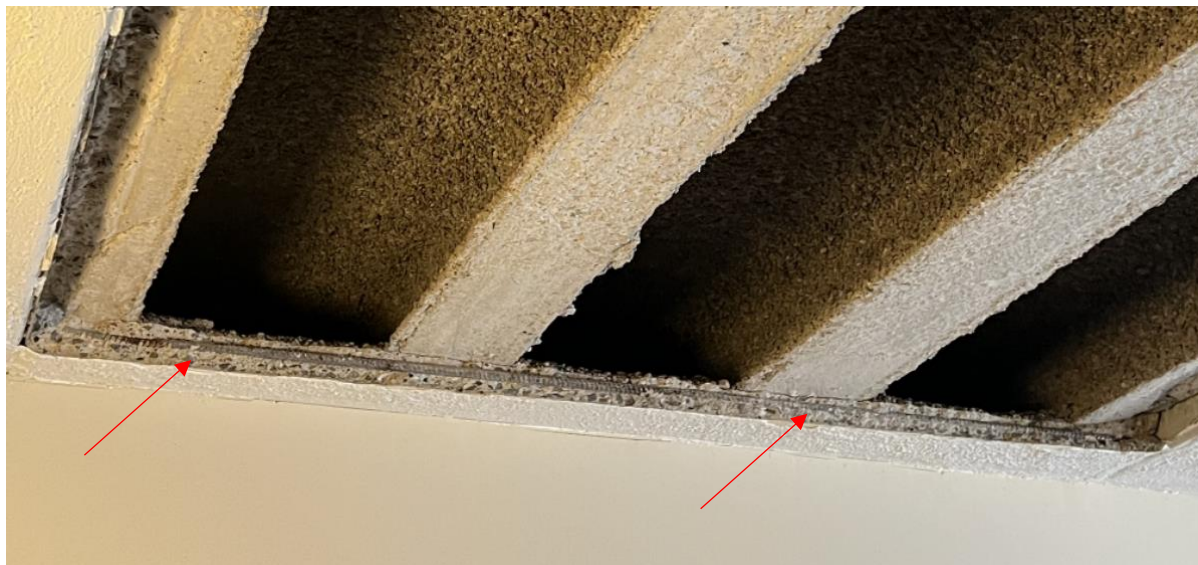
- The section of soffit that collapsed does not appear to be reinforced with the exception of two 10M bars located right at the failure point but within the section of soffit that did not fall

Figure 3: Edge of soffit at failure line (note reinforcing steel)

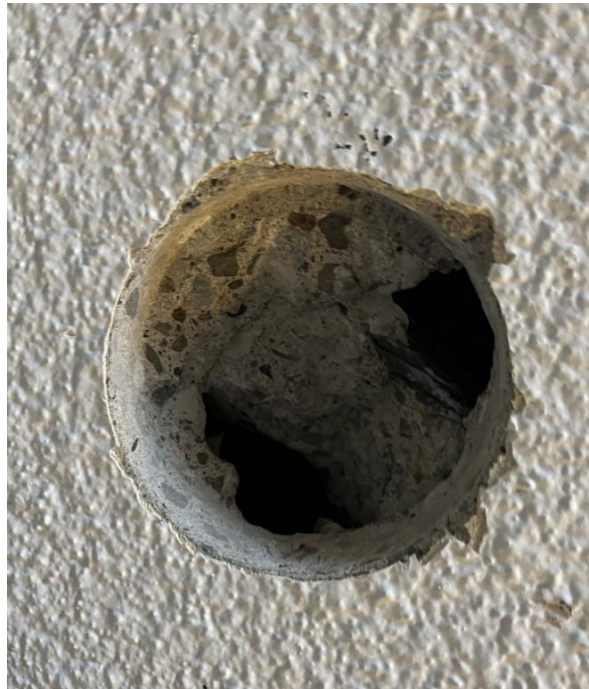
Within the adjacent panel, a core sample was taken on the soffit. RJC observed that core was extracted to a depth that exposed a prestressing strand within the precast panel. A clean bond line was not observed at this location, however, we did not observe the coring nor did we see the removed section of concrete to confirm that the core did not break in two locations (i.e. at the prestressing strand and in a similar location as the panel that failed). Refer to Figure 4 below.

Figure 4: Core sample at adjacent panel to the failed panel in Unit 19

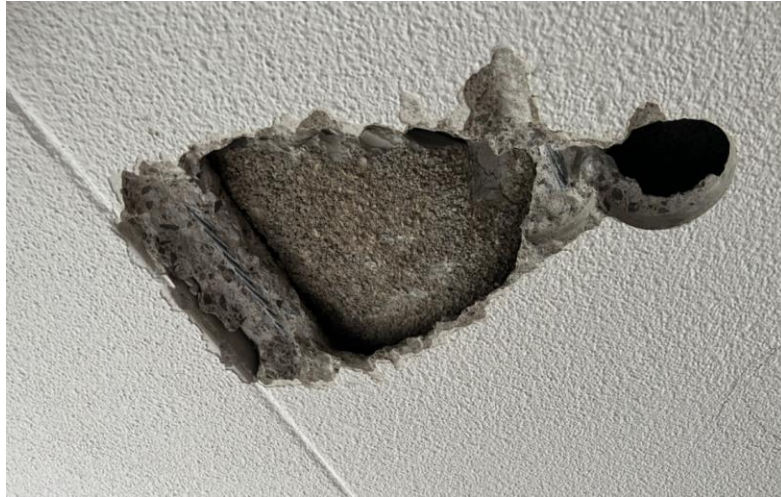
- Similar to the core location within Unit 19, concrete was removed to a point that exposed a prestressing strand within the precast panel. A clean bond line was not observed at this location – again, we did not observe the destructive testing nor did we see the removed section of concrete to confirm that the concrete did not break in two locations (i.e. at the prestressing strand and in a similar location as the panel that failed). Refer to Figure 5 below.
- At one of the concrete removal locations, one section of the hollow core of the precast panel appeared to be filled with a stone/sand mix (likely illustrating how the panel was constructed)
- No reinforcing within the slab soffit was observed within the test opening location

Figure 5: Destructive testing showing no cold joint

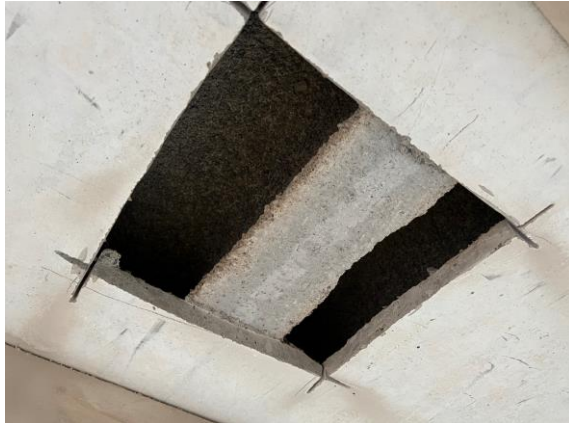
- At one test opening location in Unit 82, there appears to be a distinct cold joint at the underside of the stems within the precast panel. Again, the underside of the visible stem has a uniform and almost 'finished' appearance with a completely flat failure plane. At the failure plane, no signs of exposed aggregate within the concrete matrix were visible.
- Within Unit 70, only a section of the test opening was completed, however the concrete came apart at a distinct cold joint at the underside of the stems (similar to Unit 19). Again, the underside of the visible stem has a uniform and almost 'finished' appearance with a completely flat failure plane. At the failure plane, no signs of exposed aggregate within the concrete matrix were visible. A clear joint can be seen between the stem and soffit.

Figure 6: Test opening within Unit 82

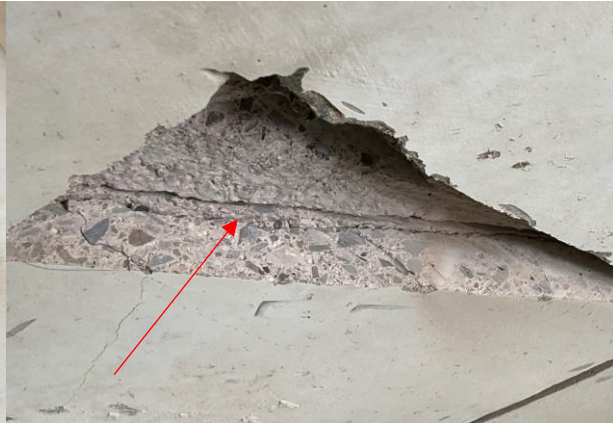
Figure 7: Test opening within Unit 70

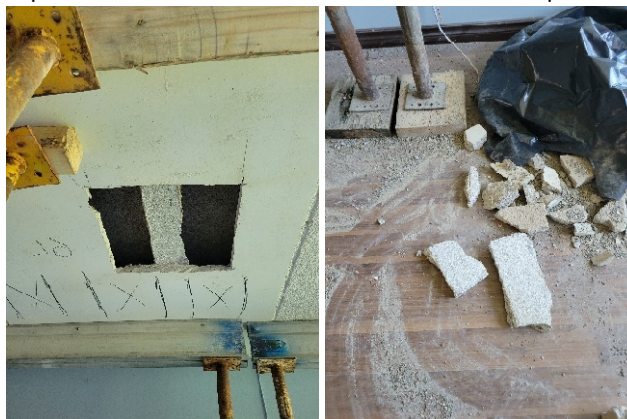
- 1.1 Unit 6, lower level – panel was removed by the contractor – failure is present – clean separation between underside of rib and bottom of panel.

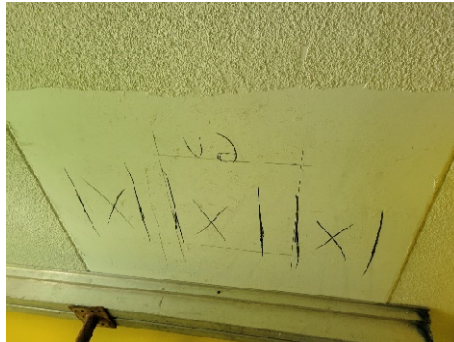
- 1.2 Unit 6, upper level – panel not cut – not tested.

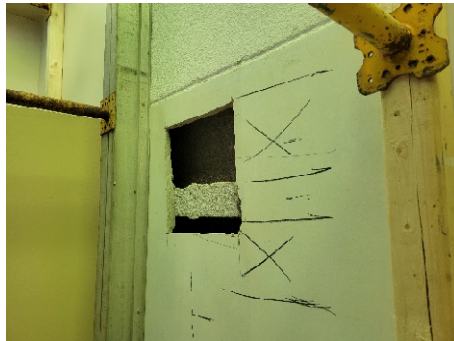
- 1.3 Unit 12, lower level – panel was removed by the contractor – failure is present – clean separation between underside of rib and bottom of panel.

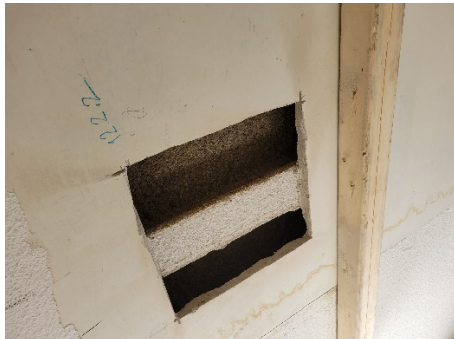
- 1.4 Unit 12, upper level – panel was removed by the contractor – failure is present – clean separation between underside of rib and bottom of panel.

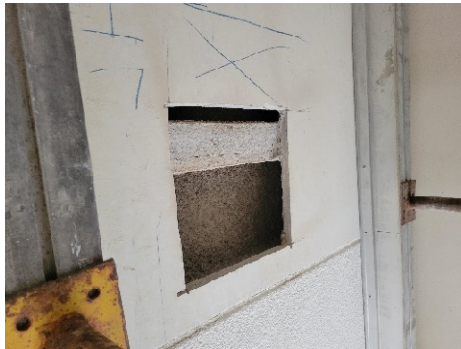
- Continued 1.5 Unit 64, lower level – panel was removed by the contractor – failure is present – clean separation between underside of rib and bottom of panel.

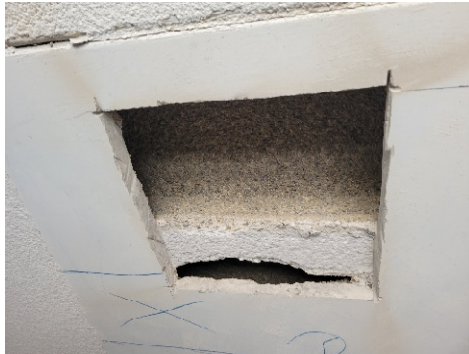
- 1.6 Unit 64, upper level – panel was removed by the contractor – failure is present – clean separation between underside of rib and bottom of panel.

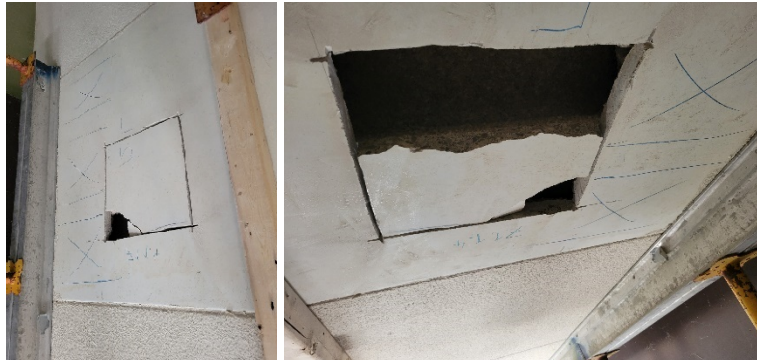
- 1.7 Unit 71, lower level – panel remained intact – underside did not separate from the rib.

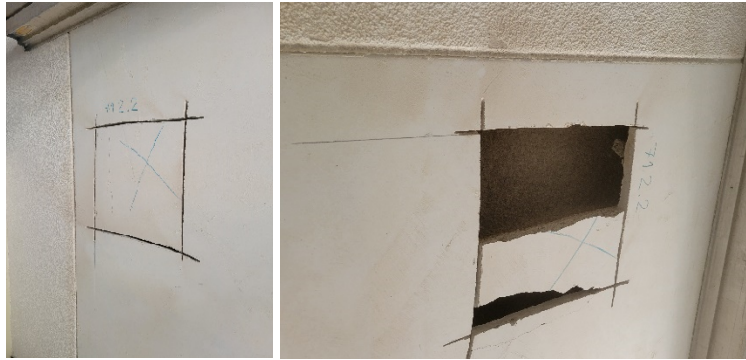
Continued 1.8 Unit 71, upper level – panel remained intact – underside did not separate from the rib.

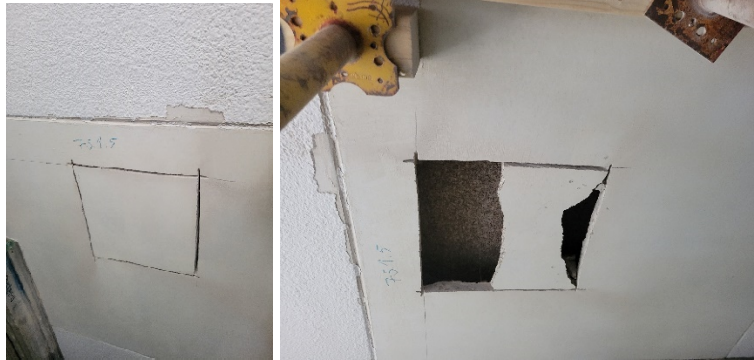
1.9 Unit 75, lower level – panel remained intact – underside did not separate from the rib.

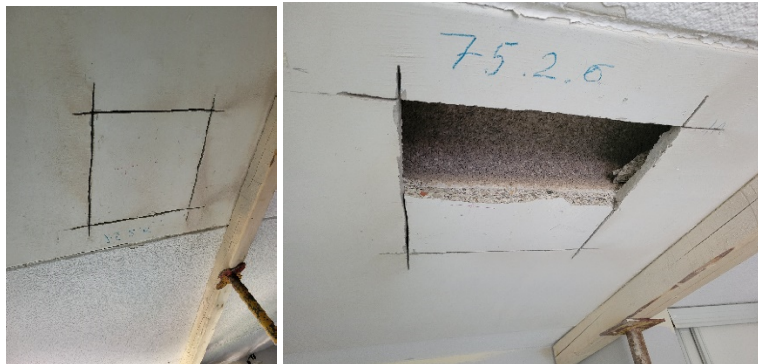
1.10 Unit 75, upper level – panel remained intact – underside did not separate from the rib.

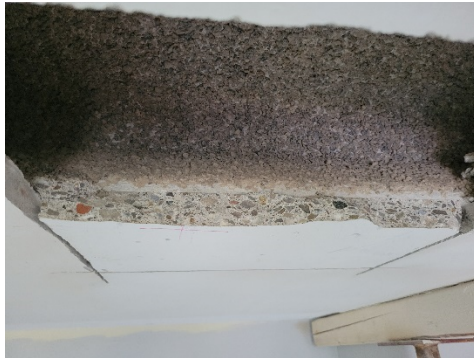
A joint between the bottom panel and rib appears to be present:

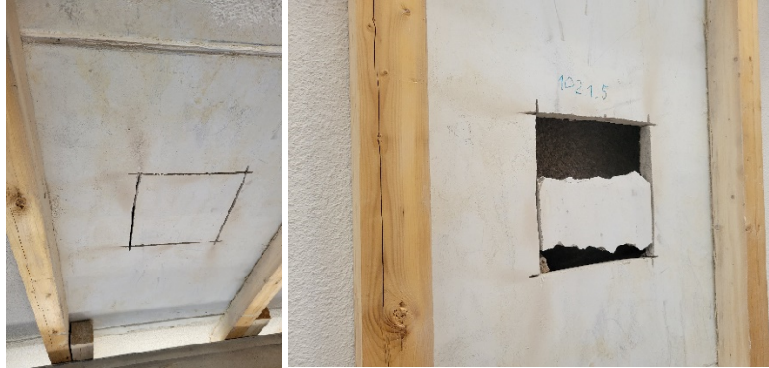
1.11 Unit 102, lower level – panel remained intact – underside did not separate from the rib.

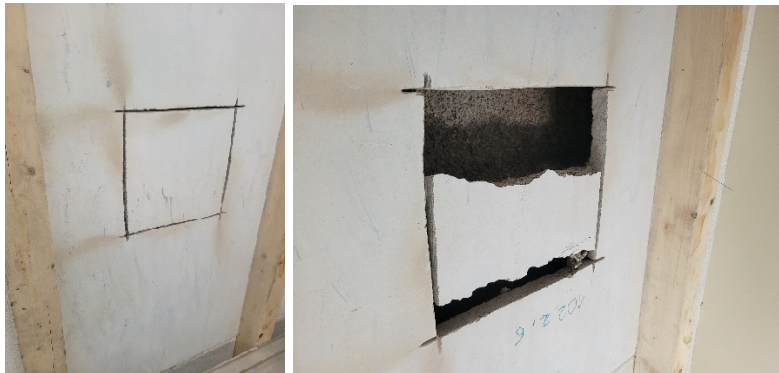
1.12 Unit 102, upper level – panel remained intact – underside did not separate from the rib.

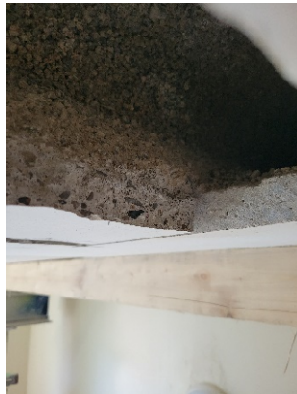
A joint between the bottom panel and rib does not appear to be present:

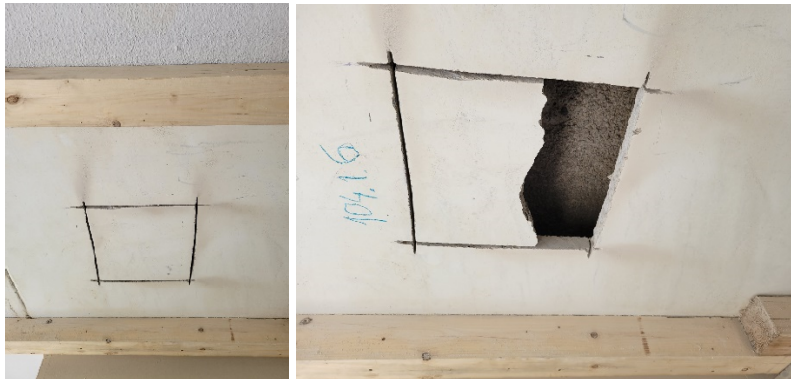
1.13 Unit 104, lower level – panel remained intact – underside did not separate from the rib.

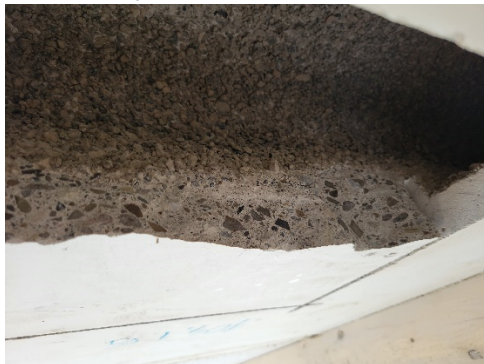
Evidence of joint – not conclusive:

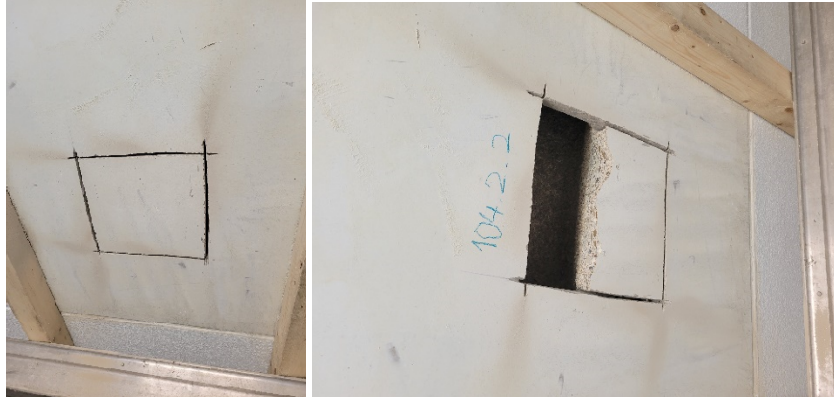
Continued 1.14 Unit 104, upper level – panel remained intact – underside did not separate from the rib.

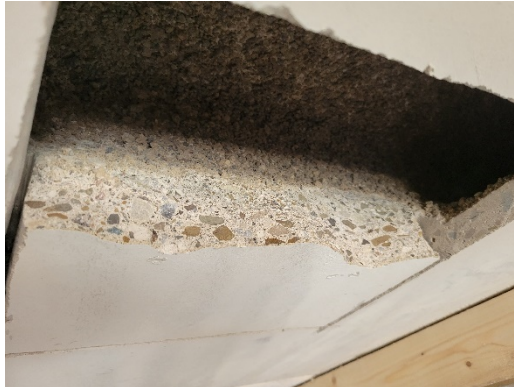
A joint between the bottom panel and rib does not appear to be present:

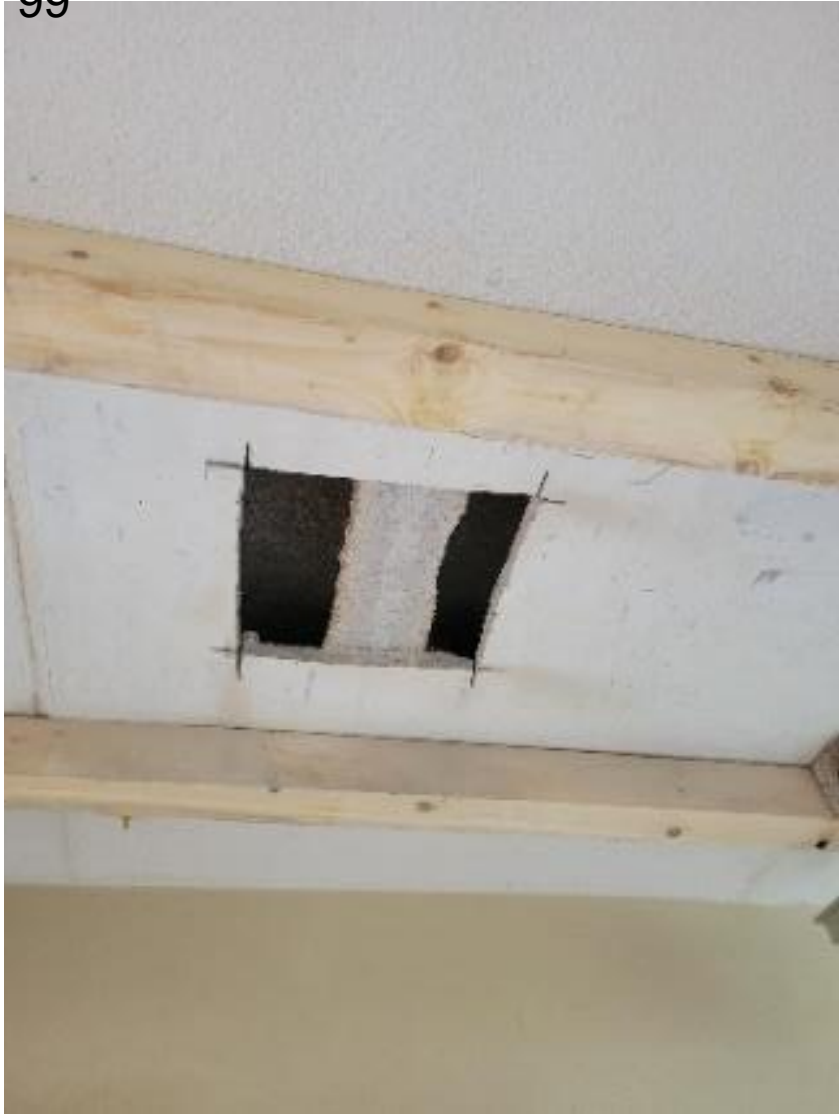
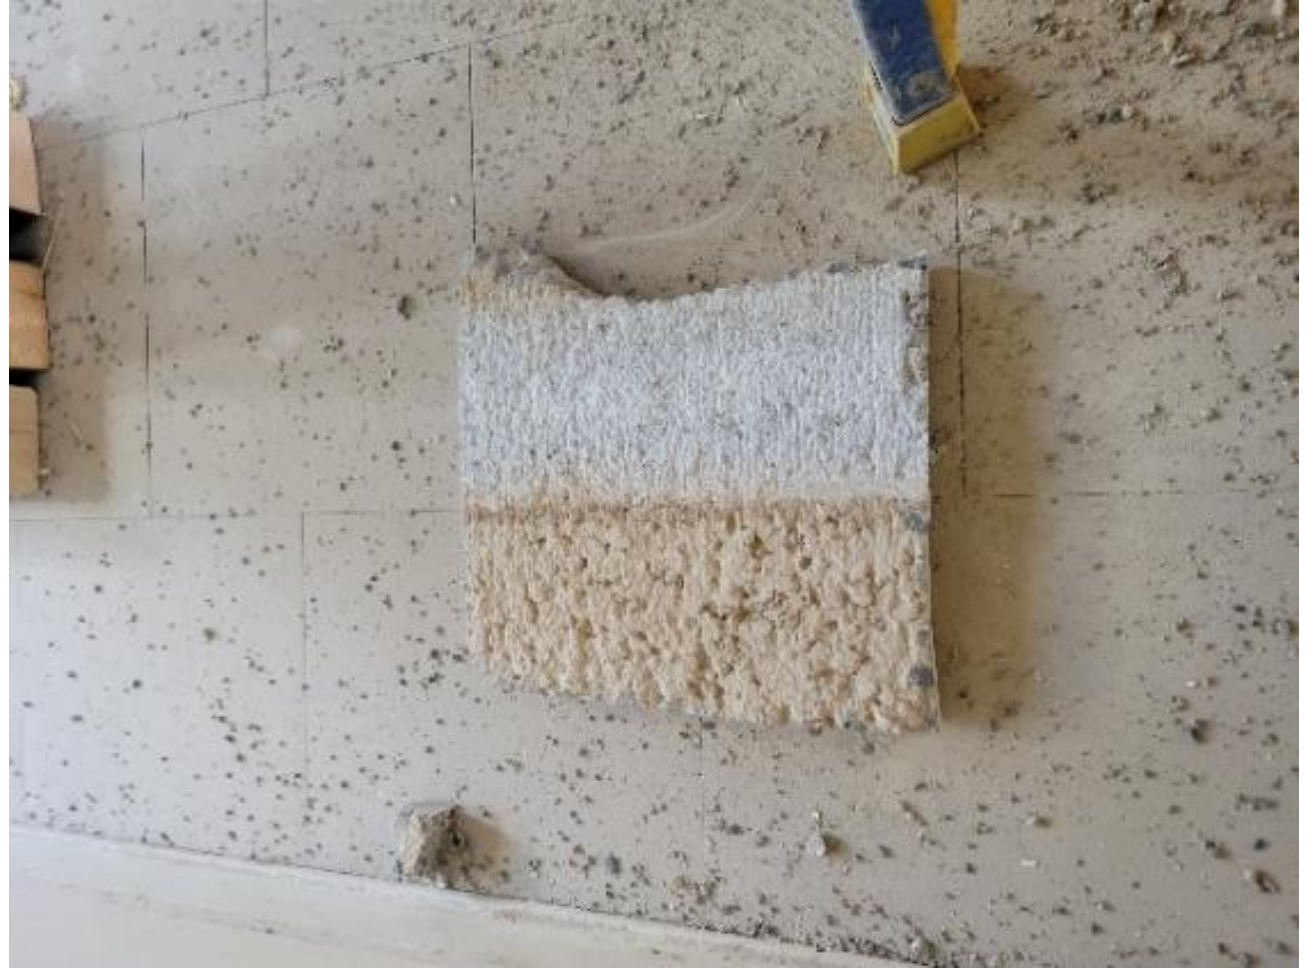
Example of failed test - panel failed clean separation occurred between underside of web and bottom of panel.

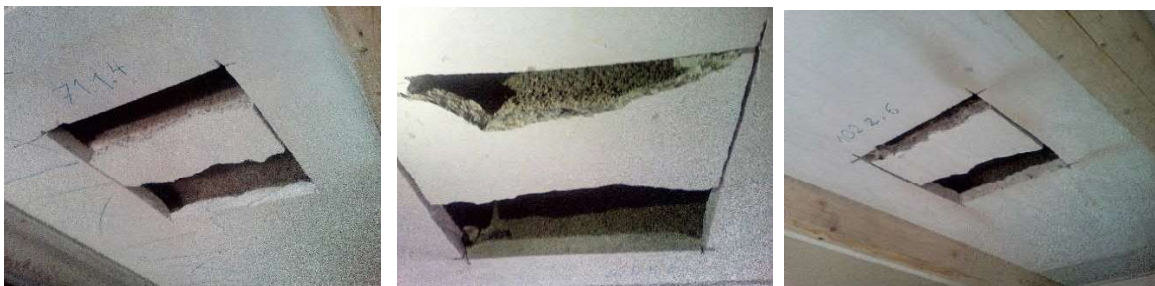
3. Testing at selected panels in the units #71, #75, #102 and #104 revealed that the ceiling of the selected precast panels remained firmly attached to the webs of the tested precast panels after being repeatedly hit with the hammer. Other panels in these units were not tested at the time of the review, and WSP cannot ascertain as to the structural integrity of the ceiling portion of those panels.

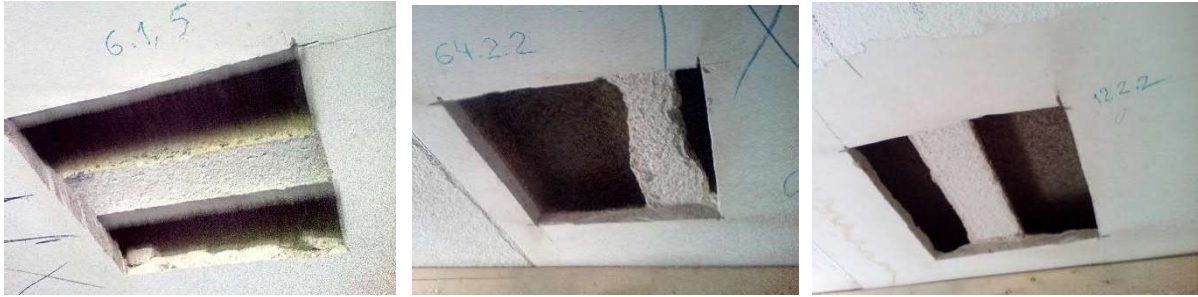
4. Testing at selected panel at Level 1 in the unit #6 and Level 1 and Level 2 in the units #12 and #64 revealed that the ceiling panel at the selected precast panels was bonded to the webs of the precast panel, similar to the defective panel in Unit #19. The destructive testing has proven that this bond is potentially insufficient to maintain composite structure of the floor panel during exposure to the design loads (gravity and lateral). The tested section of the ceiling detached from the web after application of a moderate force on the tested area by using a 2lb hammer. Other panels in these units were not tested at the time of the review, and WSP cannot ascertain as to the structural integrity of the ceiling portion of those panels.
